A remote control boat equipped with a SonTek M9 Acoustic Doppler Profiler (ADP®) has been employed with HydroSurveyor software to create a 3-dimensional map of a damaged (and still submerged) flood barrier, following serious damage that took place during last December's storms.

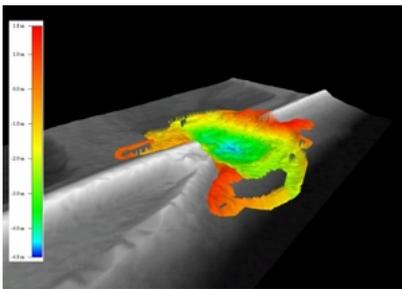
Extreme weather conditions and the highest tide for 150 years resulted in serious damage to a flood bank at Seal Sands near Billingham in the North East of England. A large hole, some 60 to 80 meters across, was scoured from the barrier and enormous quantities of seawater flooded into an area of marshland, which is an important wildlife habitat. However, this area is also adjacent to a number of high value industrial assets, so this breach in the flood defences represented a serious threat and urgent remedial action was necessary.

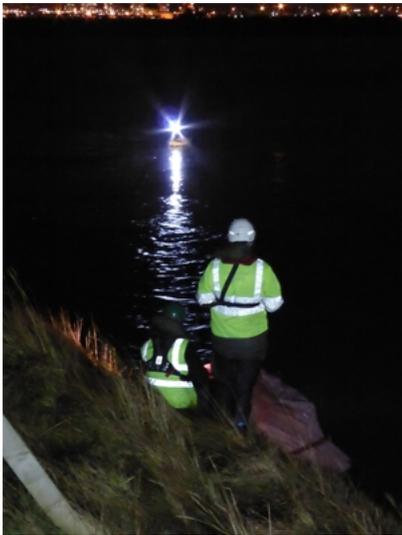
The M9 ADP® on-board the remote controlled ‘ARC-Boat’ is a 5-beam depth sounding and velocity profiling device that scans the bed as the boat is guided across the water’s surface. Recorded data are analysed in real-time by the SonTek HydroSurveyor software to produce accurate depth and velocity measurements in addition to 3-D maps of the water body. The Agency’s Chris Train says, “The operation of the ARC-Boat was a great success; we were able to conduct a complete survey during about one hour of slack water at the top of the tide. As it happened, this was undertaken at night, but we attached navigation lights to the ARC boat, so the timing was of no consequence.

“The HydroSurveyor software created a superb map of the damage and demonstrated that the hole was significantly deeper than we had anticipated, so this data was essential in helping us to plan the remediation work.
