A remote control boat equipped with a SonTek M9 Acoustic Doppler Profiler (ADP®) has been employed with HydroSurveyor software to create a 3-dimensional map of a damaged (and still submerged) flood barrier, following serious damage that took place during last December's storms.

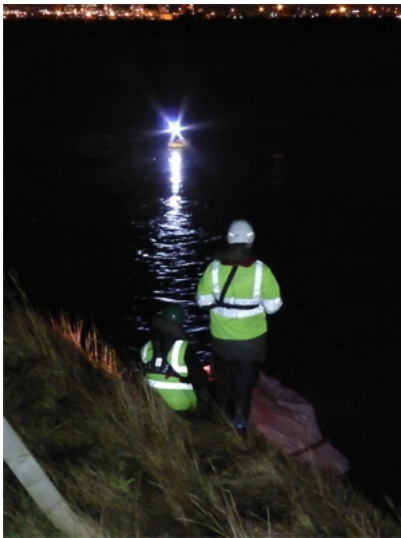
The M9 ADP® on-board the remote controlled 'ARC-Boat' is a 5-beam depth sounding and velocity profiling device that scans the bed as the boat is guided across the water's surface. Recorded data are analysed in real-time by the SonTek HydroSurveyor software to produce accurate depth and velocity measurements in addition to 3-D maps of the water body. The Agency's Chris Train says, "The operation of the ARC-Boat was a great success; we were able to conduct a complete survey during about one hour of slack water at the top of the tide. As it happened, this was undertaken at night, but we attached navigation lights to the ARC boat, so the timing was of no consequence.

"The HydroSurveyor software created a superb map of the damage and demonstrated that the hole was significantly deeper than we had anticipated, so this data was essential in helping us to plan the remediation work.
