A remote control boat equipped with a SonTek M9 Acoustic Doppler Profiler (ADP®) has been employed with HydroSurveyor software to create a 3-dimensional map of a damaged (and still submerged) flood barrier, following serious damage that took place during last December's storms.

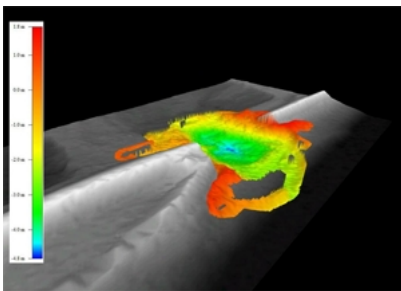
Extreme weather conditions and the highest tide for 150 years resulted in serious damage to a flood bank at Seal Sands near Billingham in the North East of England. A large hole, some 60 to 80 meters across, was scoured from the barrier and enormous quantities of seawater flooded into an area of marshland, which is an important wildlife habitat. However, this area is also adjacent to a number of high value industrial assets, so this breach in the flood defences represented a serious threat and urgent remedial action was necessary.

Initially, military helicopters were recruited to help drop boulders into the hole, but it soon became clear that greater volumes were required so a temporary road was quickly constructed

along the barrier so that fill material could be delivered by lorries.

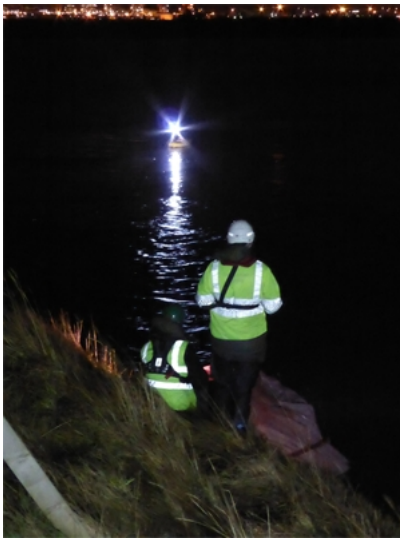
The M9 ADP® on-board the remote controlled 'ARC-Boat' is a 5-beam depth sounding and velocity profiling device that scans the bed as the boat is guided across the water's surface. Recorded data are analysed in real-time by the SonTek HydroSurveyor software to produce accurate depth and velocity measurements in addition to 3-D maps of the water body. The Agency's Chris Train says, "The operation of the ARC-Boat was a great success; we were able to conduct a complete survey during about one hour of slack water at the top of the tide. As it happened, this was undertaken at night, but we attached navigation lights to the ARC boat, so the timing was of no consequence.

"The HydroSurveyor software created a superb map of the damage and demonstrated that the hole was significantly deeper than we had anticipated, so this data was essential in helping us to plan the remediation work.
